Assignment 3

Ch4 textbook problems, bugspim
VHDL: add32, alu32, alu32control, registerFile

Andrew Fowler

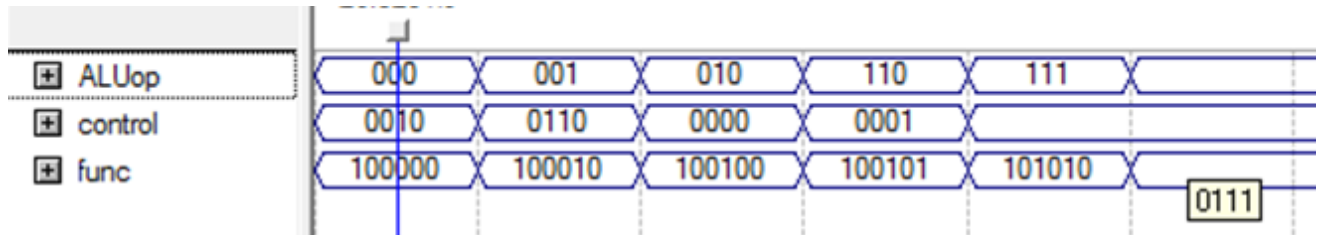
VHDL simulations:

The control signals follow the table found in the assignment PDF. When ALUop and func are the correct signals then the correct control is outputted.

the sum of "ia" and "ib" when "control" = "0010"
 the difference of "ia" and "ib" when "control" = "0110"
 the logical AND of "ia" and "ib" when "control" = "0000"
 the logical OR of "ia" and "ib" when "control" = "0001"
 the logical NOR of "ia" and "ib" when "control" = "1100"
 the slt operation of signed "ia" and "ib" when "control" = "0111"
 the slt of unsigned "ia" and "ib" when "control" = "1111"
 the logical shift of "ib", in the direction indicated by "shdir" ('0' left amount "shamt" when "control" = "0011"
