Complex Upset Mitigation Applied to a Re-Configurable Embedded Processor

Abstract—Soft-core processors implemented in static random access memory-based field-programmable-gate-arrays, while attractive to spacecraft designers, require upset mitigation. We investigate a proposed solution involving two levels of scrubbing plus triple modular redundancy and measure its in-beam performance.

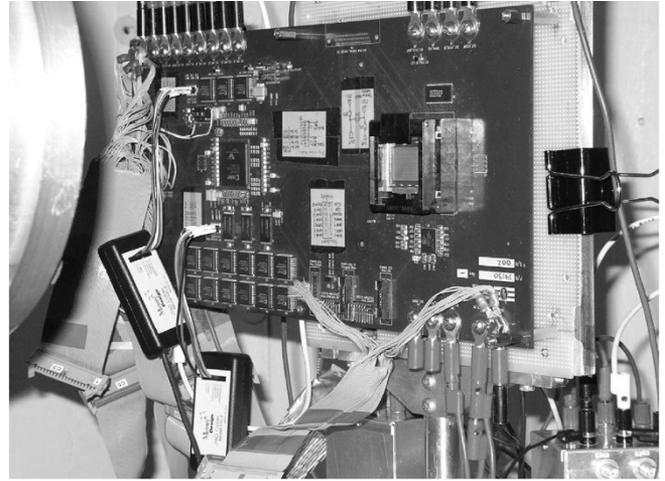
Fig. 1. Test Setup at the Cyclotron of Texas A&M University.

about this testing methodology are given in [3]. The only part of the setup that is modified for a new test design is the internal architecture of the functional monitor. Fig. 1 shows the test setup in the chamber at the cyclotron of Texas A&M University.

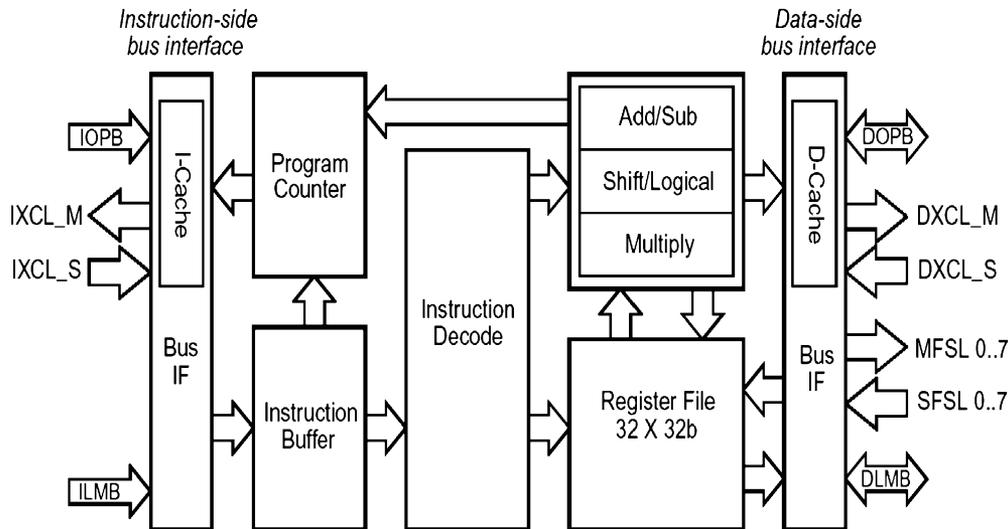
Fig. 2. MicroBlaze core block diagram [6].

The MicroBlaze soft IP core is a reduced instruction set computer (RISC) optimized for implementation in Xilinx FPGAs. This soft IP processor is 32-bit instruction word Harvard architecture with a single-issue pipeline. As shown in Fig. 2, it includes thirty-two 32-bit general-purpose registers (GPRs) and can be configured with two caches for enhanced performance. It supports two data buses: IBM's on-chip peripheral bus (OPB) and an local memory bus (LMB). To communicate with its external peripherals, the MicroBlaze uses a specific bus called general purpose input output (GPIO). Furthermore, it is enhanced with hardware exception handling circuitry as well as hardware debug logic.

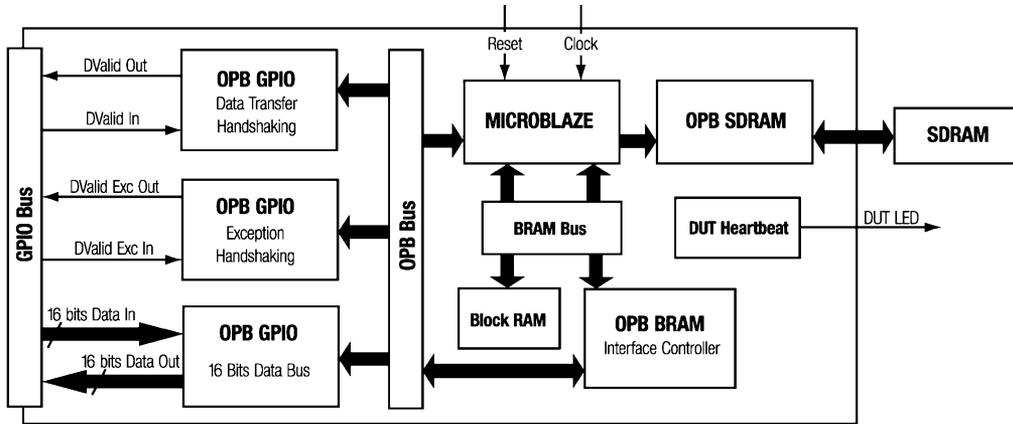
Fig. 3. Block diagram of the microblaze single-string design (before functional triplication).

Fig. 3 illustrates the initial MicroBlaze architecture and its connections to the internal memory (internal block RAM) through the OPB and block random access memory (BRAM) buses as well as to the external SDRAM memory. The DUT I/Os are used for a bi-directional data transfer bus between the DUT and service FPGAs, handshaking for data transfer operations, and detection of external interrupt or internal hardware exceptions (unaligned access, illegal op-code, illegal address of the code instruction on the OPB bus (IOPB), illegal address of the program data on the OPB bus (DOPB) and division by zero) in the MicroBlaze soft processor.

The architecture presented in Fig. 3 is a common hardware design for each MicroBlaze program selected to run under the beam. The program code resides in the internal BRAM memory or in external storage transferred to the SDRAM by a loader program. The code is loaded each time the DUT is configured. The MicroBlaze clock speed is set at 33 MHz while the GPIO data transfer rate is set at 250 KHz, to allow the MicroBlaze to process the data requests on the GPIO bus.

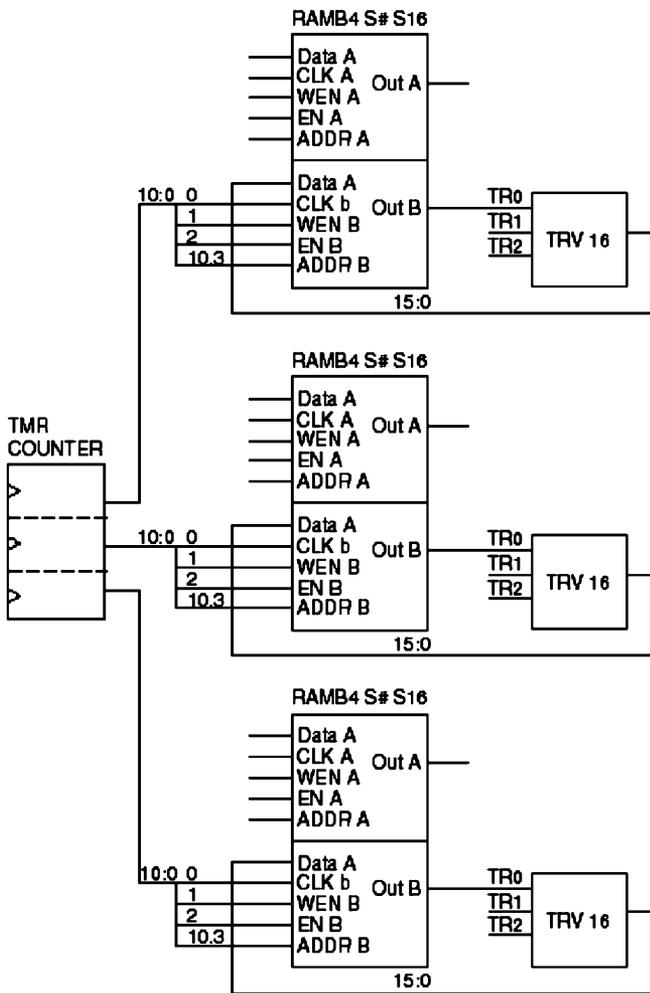
Fig. 4. BRAM mitigation block diagram.

from the associated voter (TRV16 in Fig. 4). In case it is used, it skipped this address. Fig. 4 shows the BRAM scrubber block diagram and more details are given in the [9].
